# ***STREAKS ON MY WHEELS or I HAVE A LEAKING CAP***

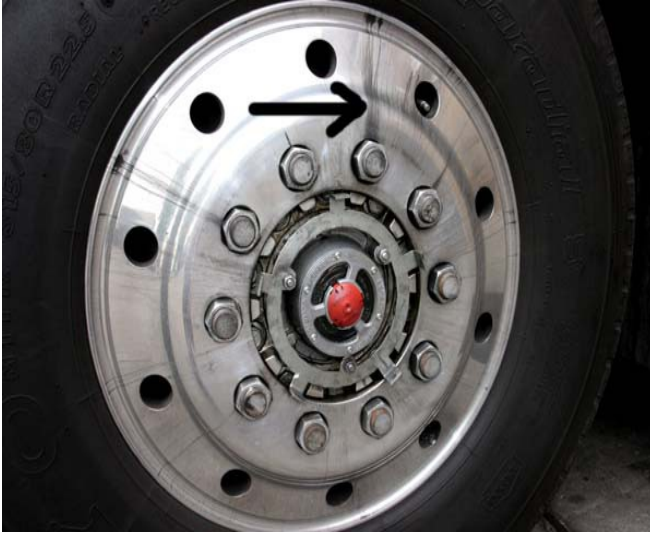
This is a typical of a leaking hub cap seal, or hub cap if you prefer. The cap shown above is a Stemco Cast Aluminum cap which can be repaired, "O" Ring replaceable between the plastic cover and the cap, also the plastic sight glass can be easily replaced. **NO JACKING REQUIRED** Please note, the DECORATIVE hub cap mounts on the outside of this unit and YOUR specific mounting **May be Different** for the *YOUR DECOR HUB CAP*.

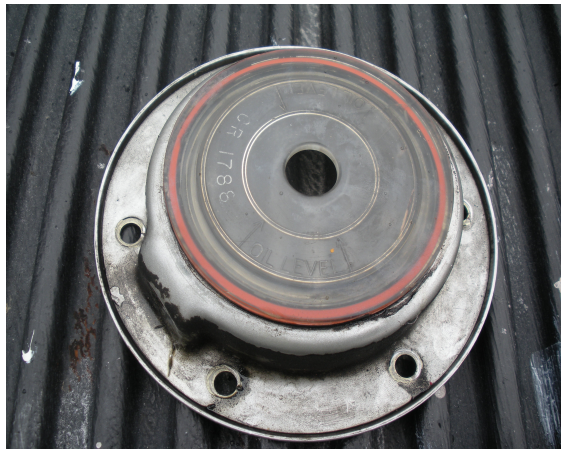
Above is the kind of cap that was found to be leaking, this was installed by Prevost at manufacture of the chassis. This one is a CR (now SKF) cap and it was determined that this type of cap must be replaced, as there are no serviceable parts. This cap is steel with glued or epoxied in plastic sight glass. Note, some hub caps MAY NOT have the drain plug, in which case this task may get a little messier. This cap had a leak between the plastic and the case near the drain plug.

Both the SKF and the Stemco caps were available locally, I selected the Stemco cast aluminum cap that was available for less than 40.00 complete, including gasket. The SKF (CR) type was available as well but then again it is a disposable hub cap.

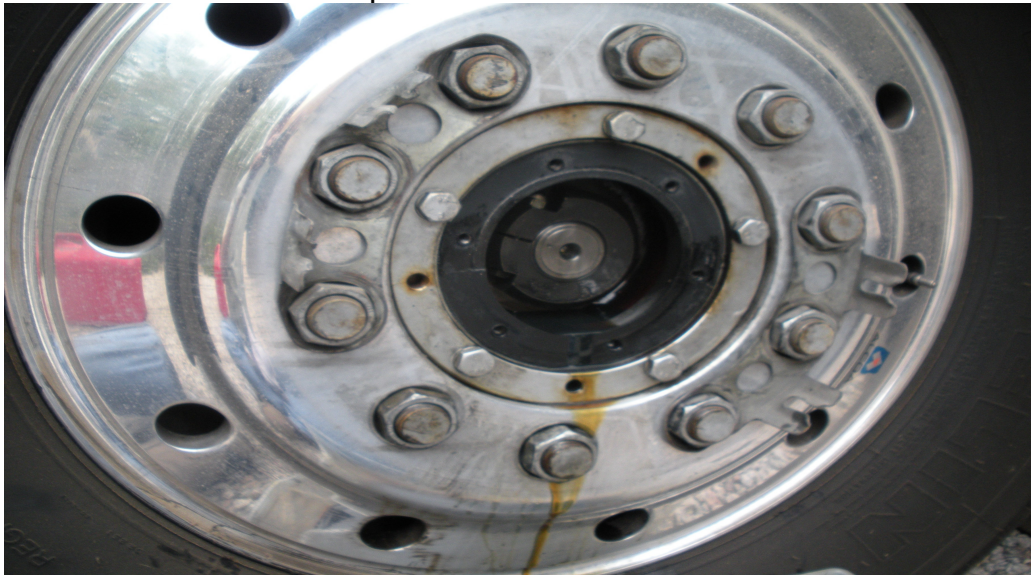
First we removed the drain plug at the bottom of the hub cap and the rubber fill plug and allowed the hub to drain. I would estimate that approximately 1 pint of gear oil was drained. Next the 6 bolts were removed as shown below. A couple of taps with a mallet and the cap came free.

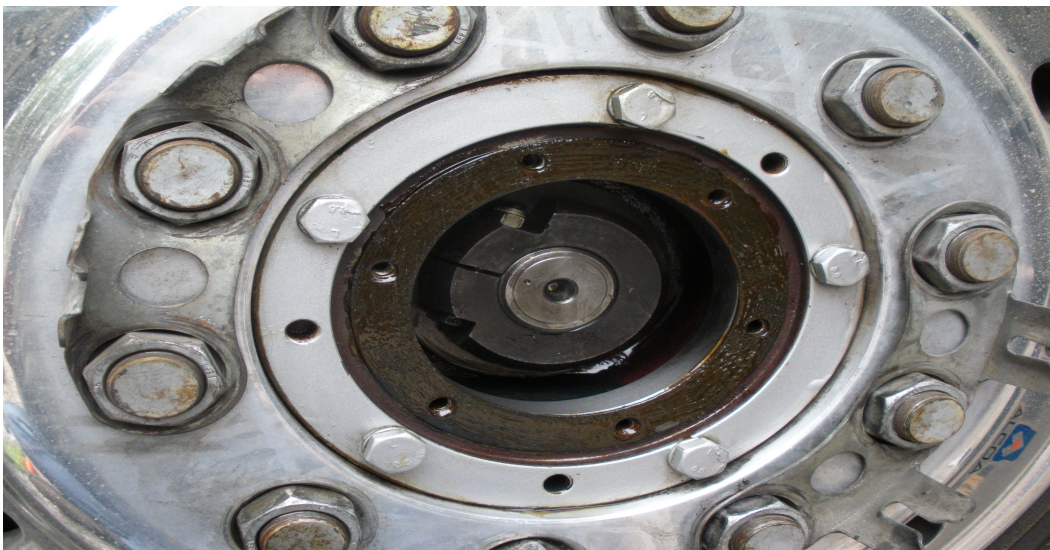
Note the old gasket is still installed in this picture, this should be changed. At this point some oil was still leaking from the hub so we used paper towels to "mop up" most of the trapped oil so the hub would not be leak during re-installation of the new cap.

We removed the old gasket with a gasket scraper and cleaned the area thoroughly with solvent.

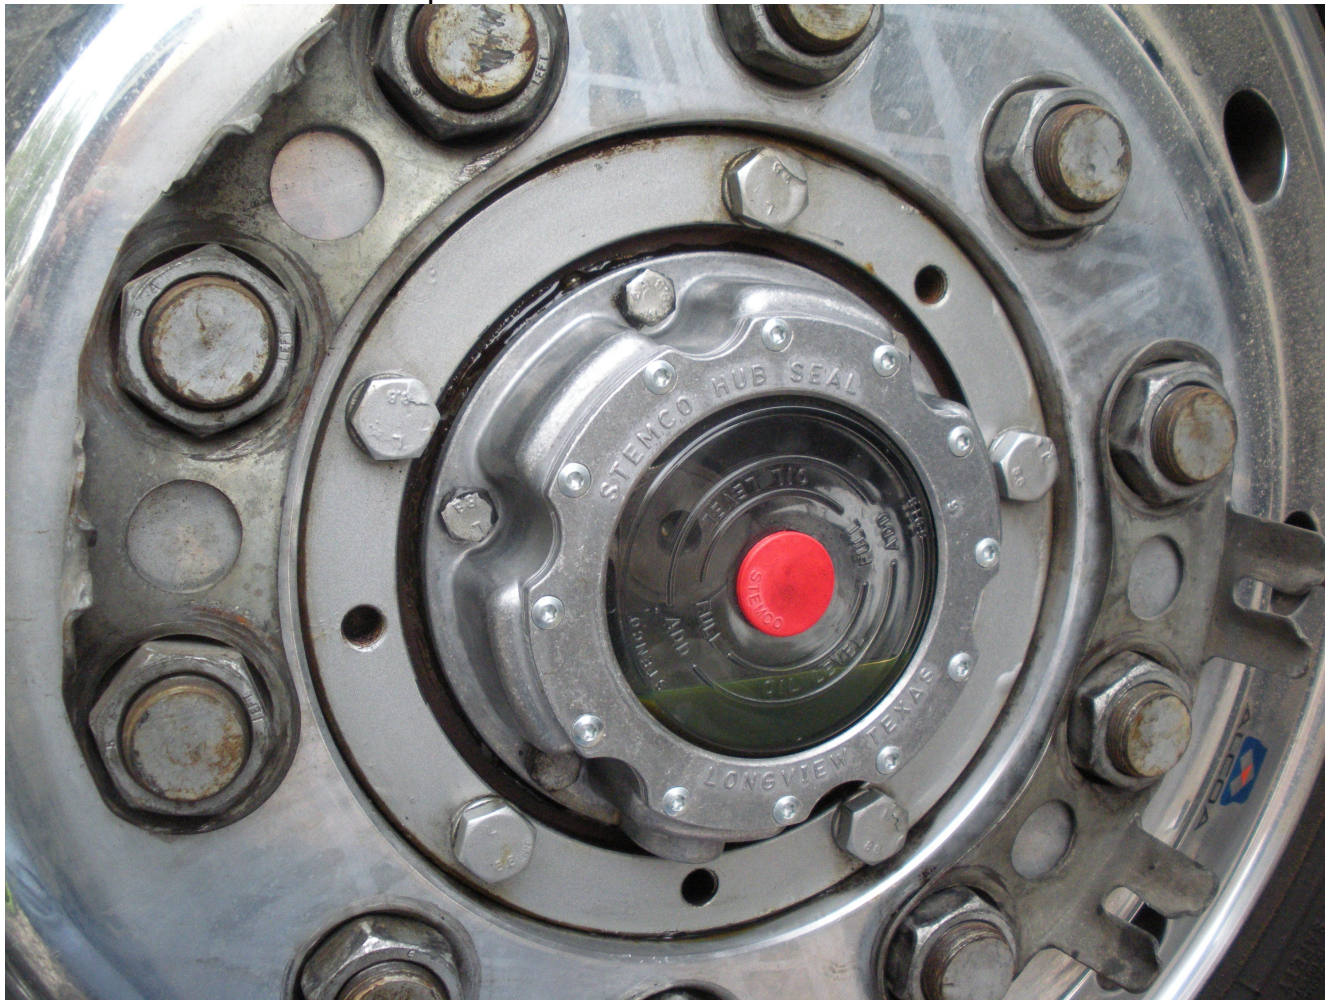
Note the Torx screws installed on the face plate of this unit that will allow for future repair as necessary. Less than 30 minutes to complete job, re filled oil with 85W140 multi-vis gear oil to sight mark, waited 1 hour, topped off oil to line and checked for leaks.

Next we installed the new Stemco unit. We coated both sides of the gasket with Permatex Gasket Cement prior to installation.

**Caution** the Stemco unit is cast aluminum so exercise care with tightening the bolts to the hub, especially if an overtightened steel unit was removed. Torque evenly. Apparently Prevost may install either type of cap shown. I would definitely advise the Stemco as a replacement.
