## **AAP Inc. / CRUISAIR**

**Cruisair heat and air conditioners are split systems with the condensing units mounted in the basement or bays of converted coaches, with the evaporators mounted in the “house” portion of the coach. The units are robust, serviceable, and relatively quiet.**

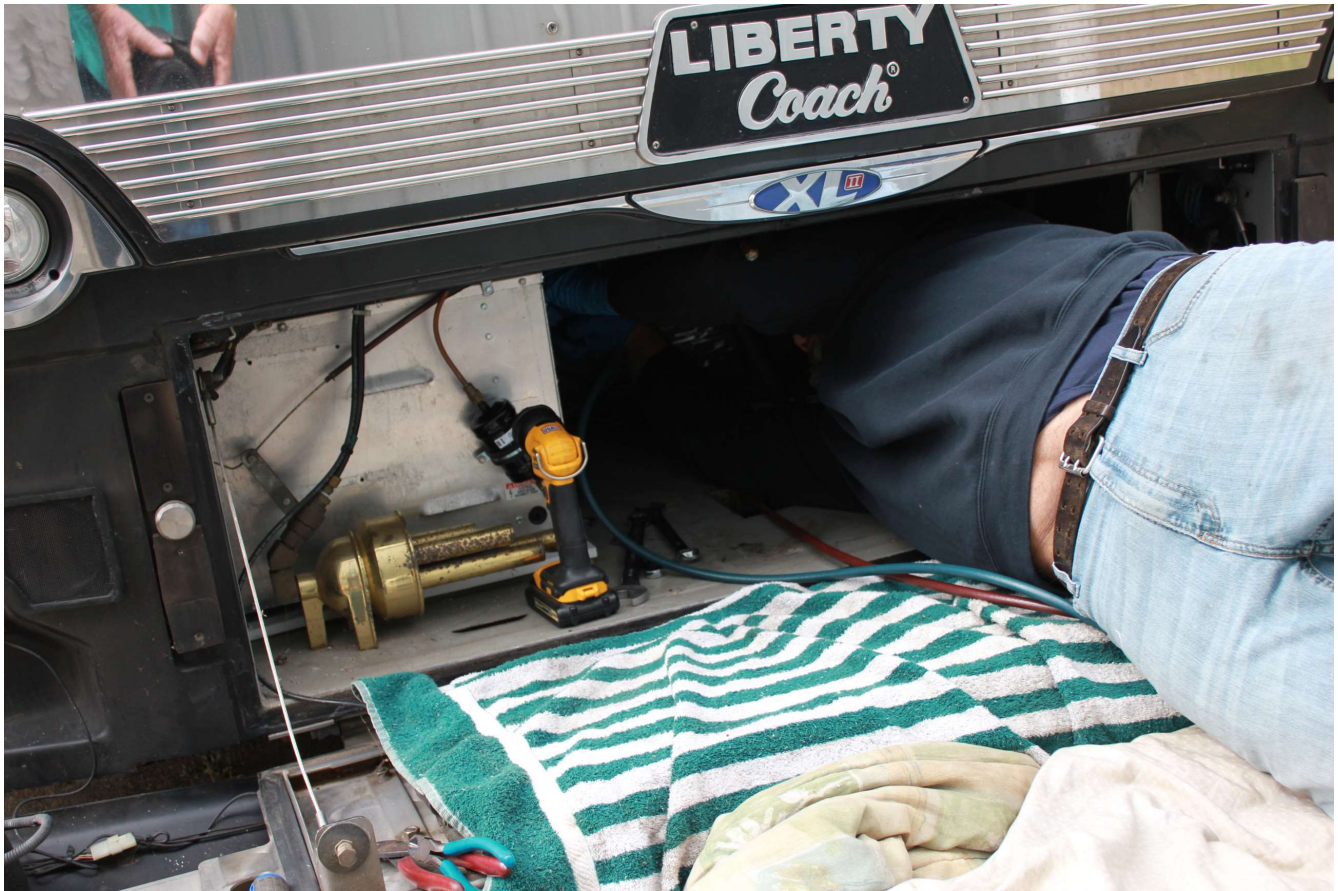
**Dana knows our coaches. He knows how to efficiently access fittings, electrical connections and fasteners that secure the units to the chassis. In the photo above he already had the center port condensing unit out and was working to remove the forward unit. As can be seen removal and replacements of the units is a one man job. There is limited room to work so even if an army of technicians was available the process is still going to be a one man job. And that one man is prepared for the job. He obviously knew exactly what tools to have at hand, he knew how many pillows and blankets he needed to avoid sharp edges and to provide limited comfort while working in strange or difficult positions.**

**He was working on the coach within 20 minutes of arrival. At the AAP facility there is a 50 amp plug so the coach was powered up immediately, and after a short discussion a plan was made to remove and replace units in a sequence that allowed us to have one or more working units so we could have heat or air available as needed.**

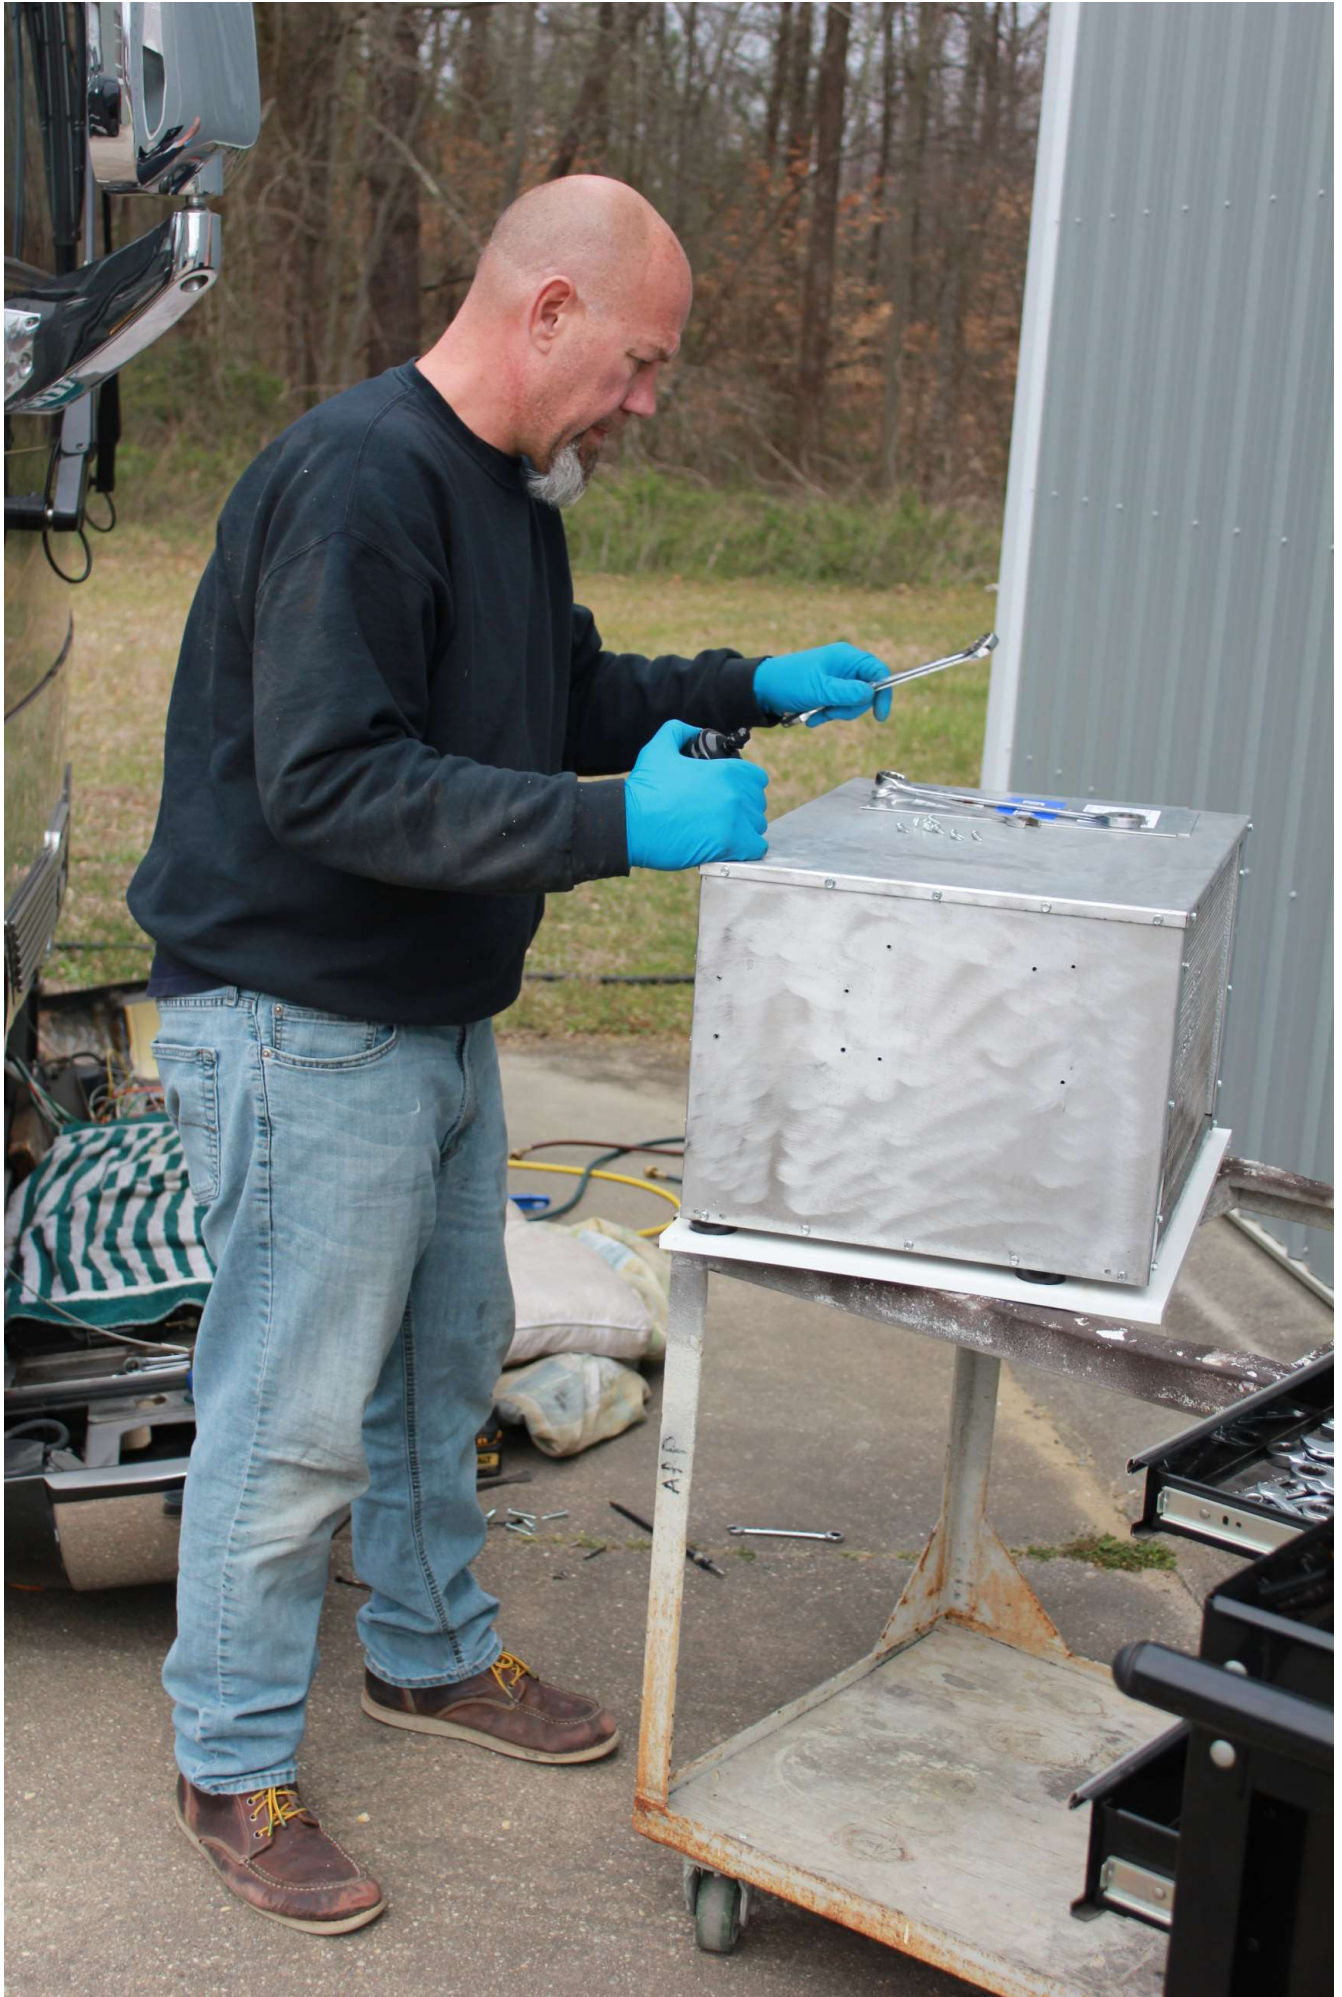
The old front units are out and Dana is getting the replacement unit set up for installation. What is worth noting is AAP Inc. doesn't leave much to chance. The units being installed had been running in their shop for about a week to verify they were absolutely working perfectly.

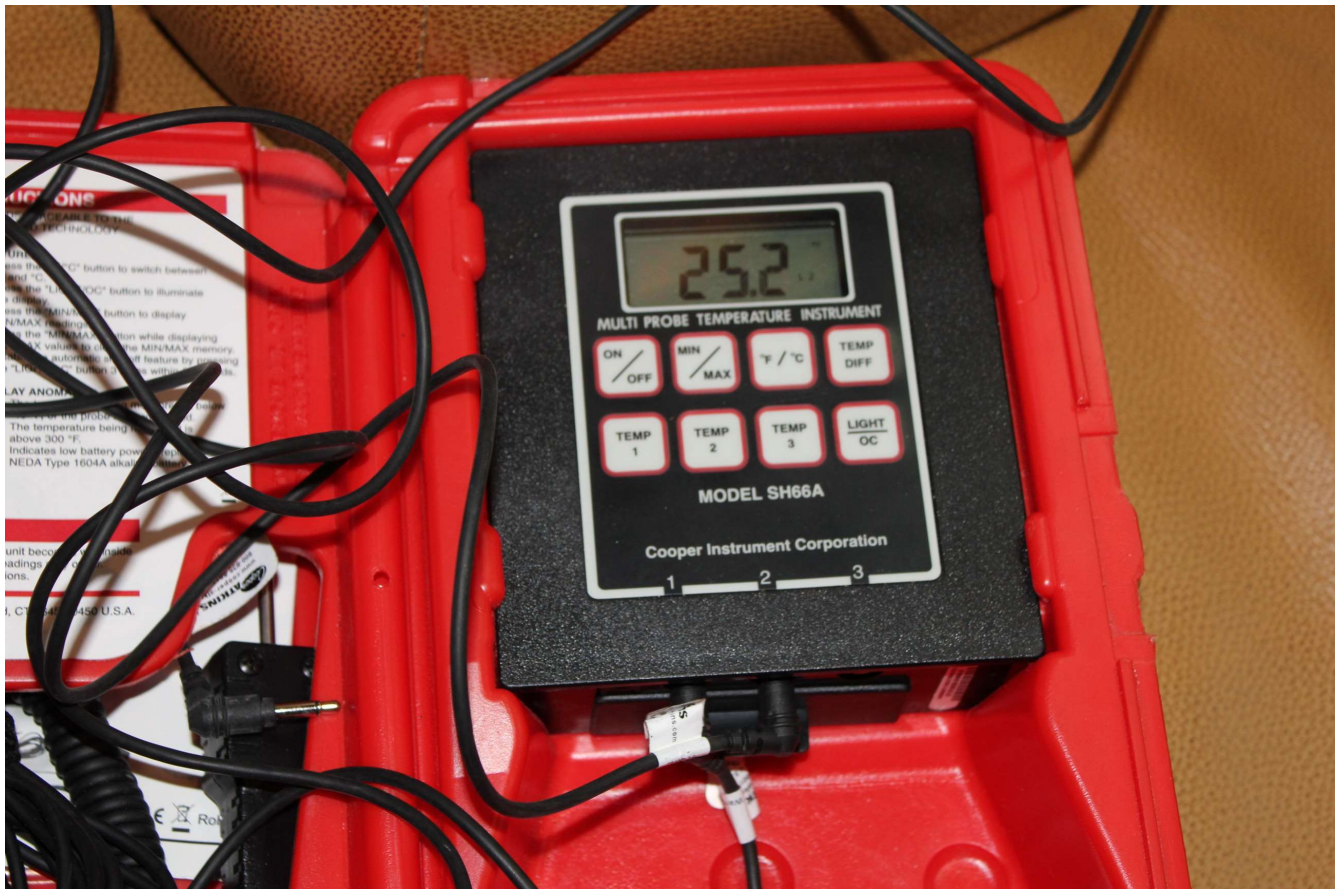
Once installed each unit has its refrigerant charge adjusted. Every unit on every conversion has its refrigeration charge dependent on the length of the refrigeration lines between the condensing units and the evaporator units. After the units are installed and the evaporator unit has been “vacuumed” to insure there is no moisture in the system the valves are opened and refrigerant is added to optimize performance.

Multiple ways of verifying the performance were used. In the photo above a temperature gauge was used to define the air temperature as it comes through the evaporator and the difference in temperature between that and the air in the room is important information. AAP wants to see a temperature spread of at least 14 degrees F, but knows on our coaches each unit in the coach is going to display a different temperature spread. The front unit often has the closest spread and units more to the rear are expected to have a greater spread.

But the charge is also checked via the refrigeration gauges, and then all is verified in the old fashioned way. If the return line to the condenser is ice cold it is as good an indication of the proper operation as anything else.
