## **THE FINAL LiFePo4 INSTALLATION CONFIGURATION**

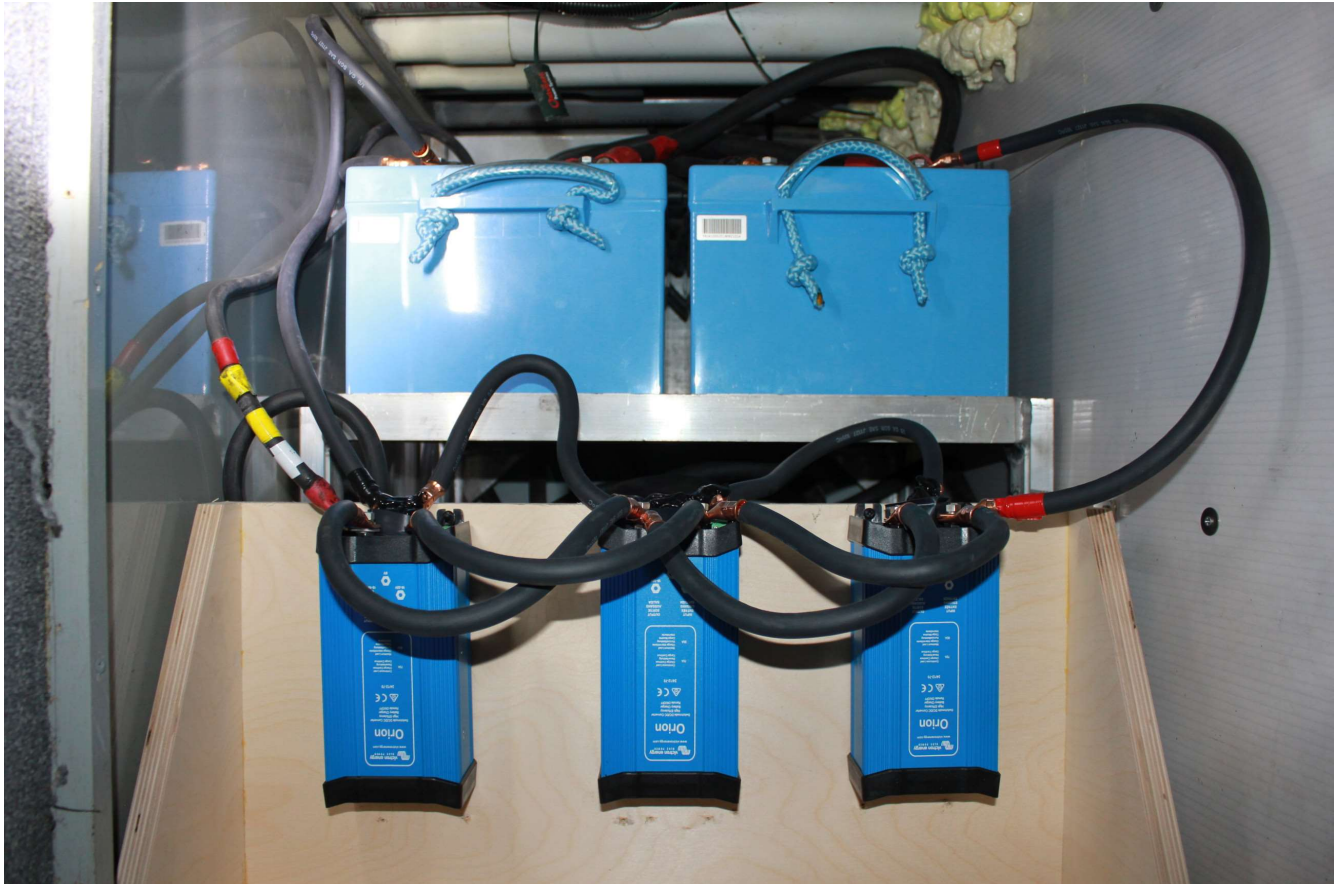
They drew 24 volt power from the batteries and provided a regulated 13.2 volt output. That output was sent using an existing cable to the 12 volt panel. The converters were mounted on a panel Jeff's shop made.

The panel is easily removed by disconnecting 3 cables and three screws so all batteries are easily accessed.

In the photos above and below below the far right cable with the red insulation is the 24 volt power supply into the converters, and at the extreme left is the red insulated cable supplying the 12 volt house panel. The converters are a good quality and fan cooled. Buy mounting them as shown they have ample room for air flow.

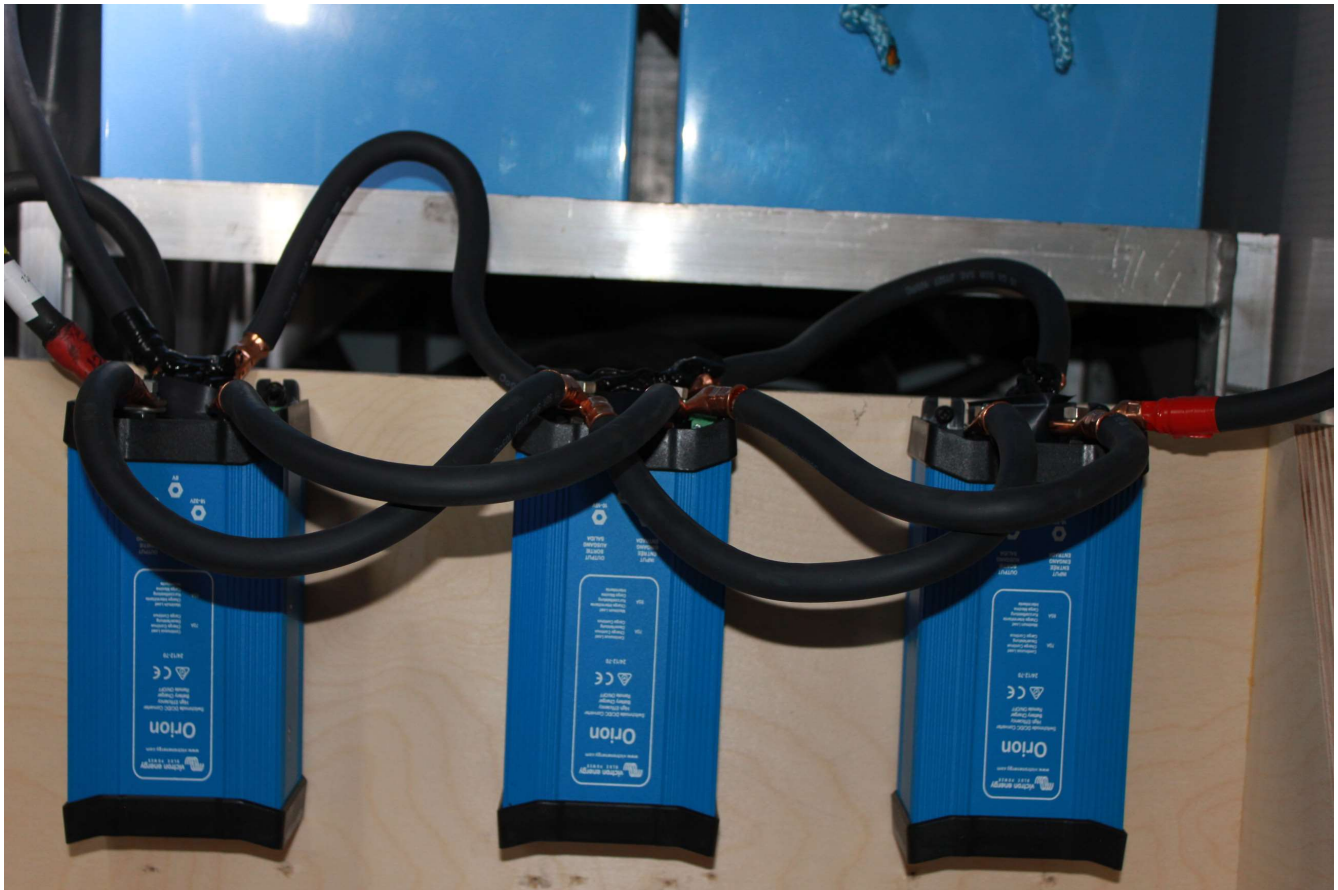
The cables can also be seen clearly in the photo above. As now cabled anyone in the future would not have to guess what cables go where or what they do. All 24V positive connections either go to adjacent batteries or into the coach 24V panel via connections in the electrical compartment which are not only to distribute 24V power, but which connect to the 24V inverter charger output to maintain the batteries.
